Limited Visual Dam Safety Inspections

HI00042

Puukapu Reservoir

May 2006

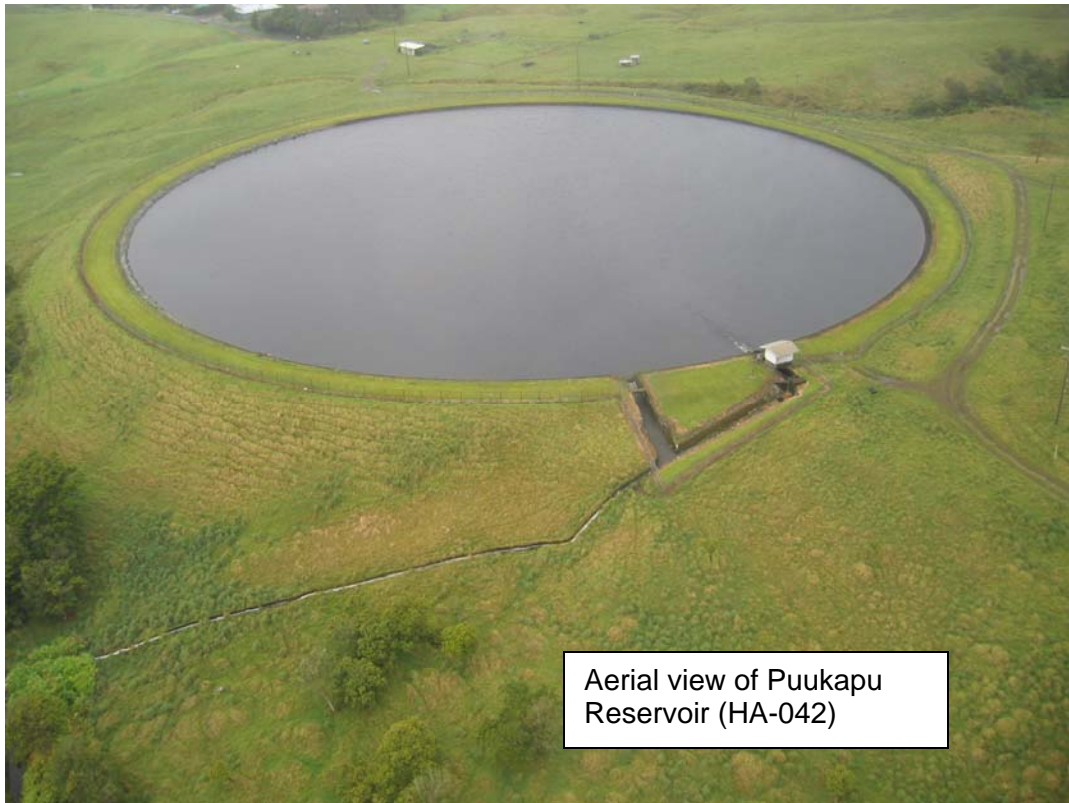
Aerial view of Puukapu
Reservoir (HA-042)

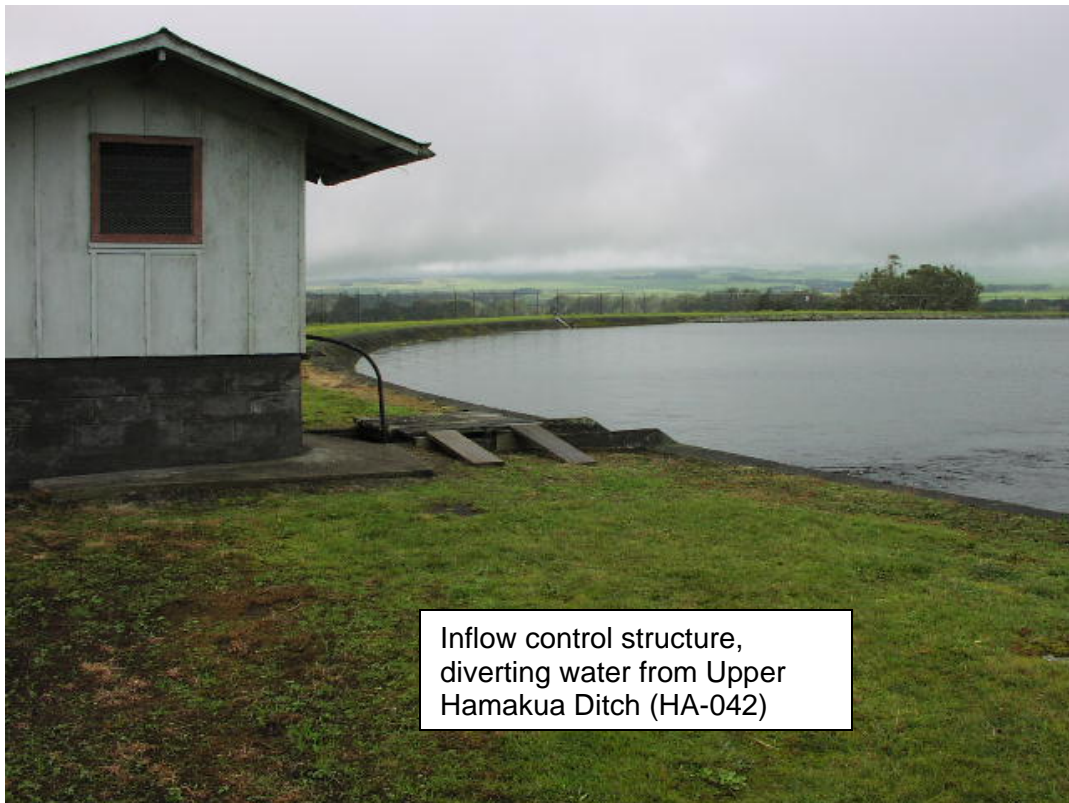
Inflow control structure,
diverting water from Upper
Hamakua Ditch (HA-042)

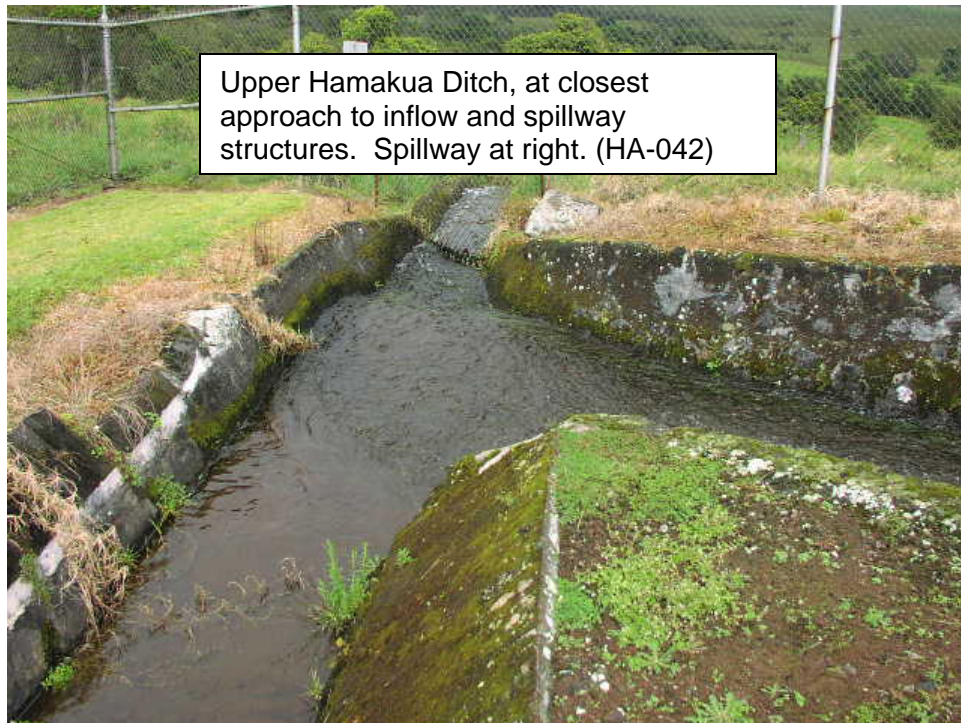
Upper Hamakua Ditch, at closest approach to inflow and spillway structures. Spillway at right. (HA-042)

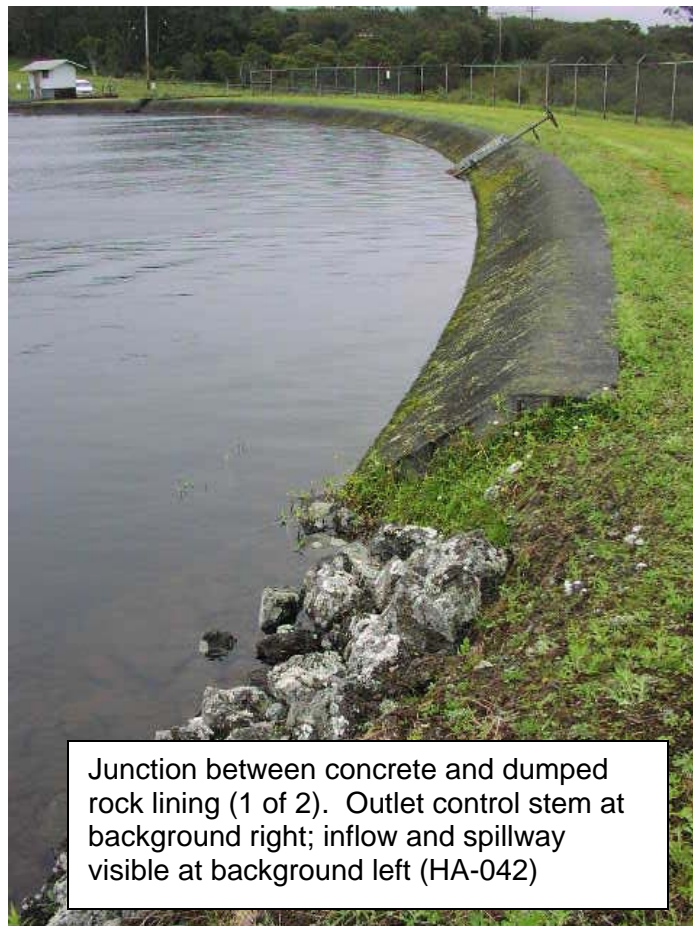
- a. The upstream slope appeared to be in satisfactory condition, no corrective actions are required at this time.
- b. A small amount of erosion is occurring at the junction between the concrete liner and the rock slope. This point is found about 50 ft from the outlet control stem, proceeding clockwise around the rim. This erosion does not appear to be recent or progressive, but should be inspected at regular periodic inspection intervals.

The observed discontinuity in slope at the change between concrete and dumped rock lining was not substantial; may not represent a change over time from original construction. I would not change my condition rating.

Junction between concrete and dumped rock lining (1 of 2). Outlet control stem at background right; inflow and spillway visible at background left (HA-042)

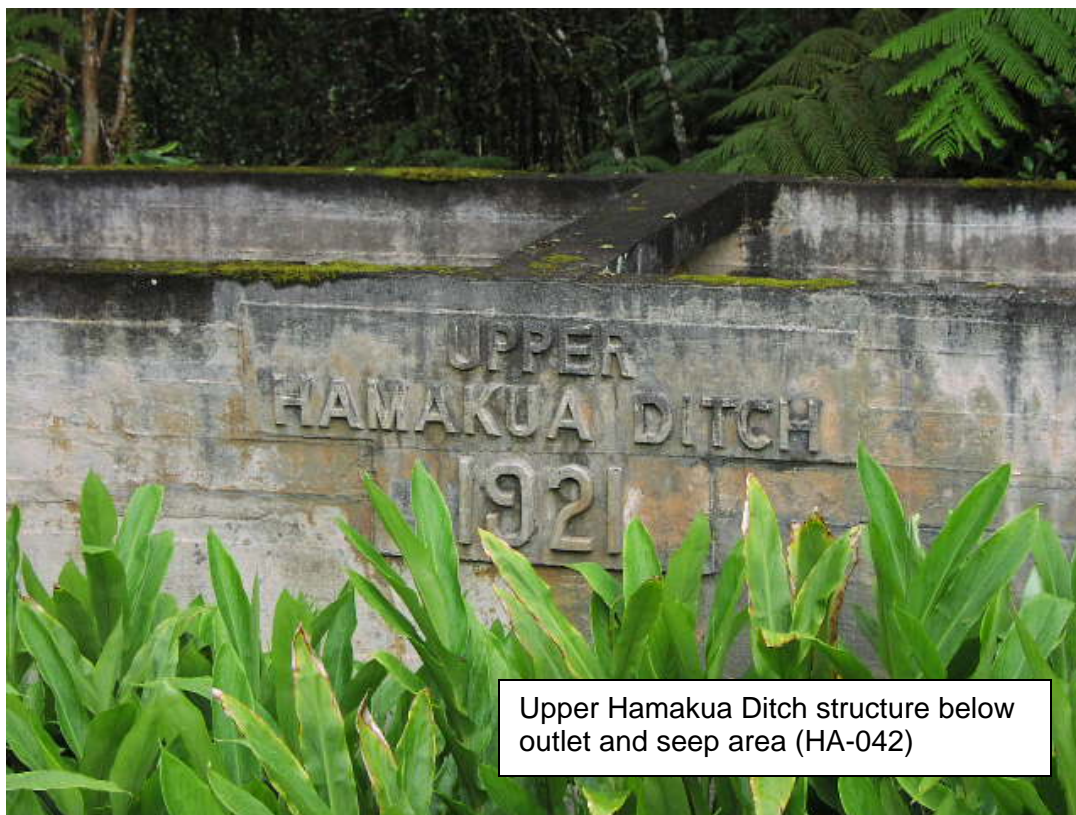
- e. Seepage/Ponding water was observed. Monitor and conduct further investigation to locate the source of water and extent of any possible hazardous or developing condition. Seeping water appears clear, with some iron staining of the surface. Flow rate was indeterminate due to dispersed flow. Conduct dye study to isolate flaw in reservoir lining.

Upper Hamakua Ditch structure below outlet and seep area (HA-042)

ACTIVE, LONG TERM SEEP RUNNING, RATE NOT MEASURED (TOO DISPERSED)
~~BELLOW TOE~~ FROM BOTTOM THIRD OF EASTERN SLOPE. THIS IS D.S. OF THE
TRANSITION FROM CONCRETE TO ROCK LINING NEAR OUTLET. AREA IS
COVERED WITH ROCK BURDEN REMOVED DURING EXCAVATION OF RESERVOIR. DOES
NOT APPEAR TO THREATEN SLOPE STABILITY; ROCK SLOPE IS FREE-DRAINING AND
MAY ACT AS STABILITY BARRIER. RECOMMEND DYE STUDY TO DETERMINE
SOURCE IN RESERVOIR.
